**Failure Analysis, Cadmium Brush Plate Qualification and
Salt Fog Testing of the AH-64 Shock Strut Mount,
P/N 7-311113409**

ARL-TR-2870

November 2002

A failure analysis was performed on a shock strut mount from an AH-64 Apache attack helicopter. It was concluded that the failure was attributed to stress corrosion cracking and/or corrosion fatigue and had initiated at a region where the protective cadmium plating was worn away in service. Based upon this conclusion, it was necessary to qualify two facilities (Hunter Army Air Field, Savannah, GA and Ft. Lewis, Dupont, WA) for the cadmium brush plating rework of these components found to have worn coatings during routine inspections. The U.S. Army Research Laboratory was involved in the qualification process for both facilities, and the results of each quality audit are included. Finally, the results of salt fog testing of cadmium brush plated specimens, plated at the respective facilities, are also included, as well as a comparison of the grain size of the material in the failed component vs. the material from the struts plated at each facility.

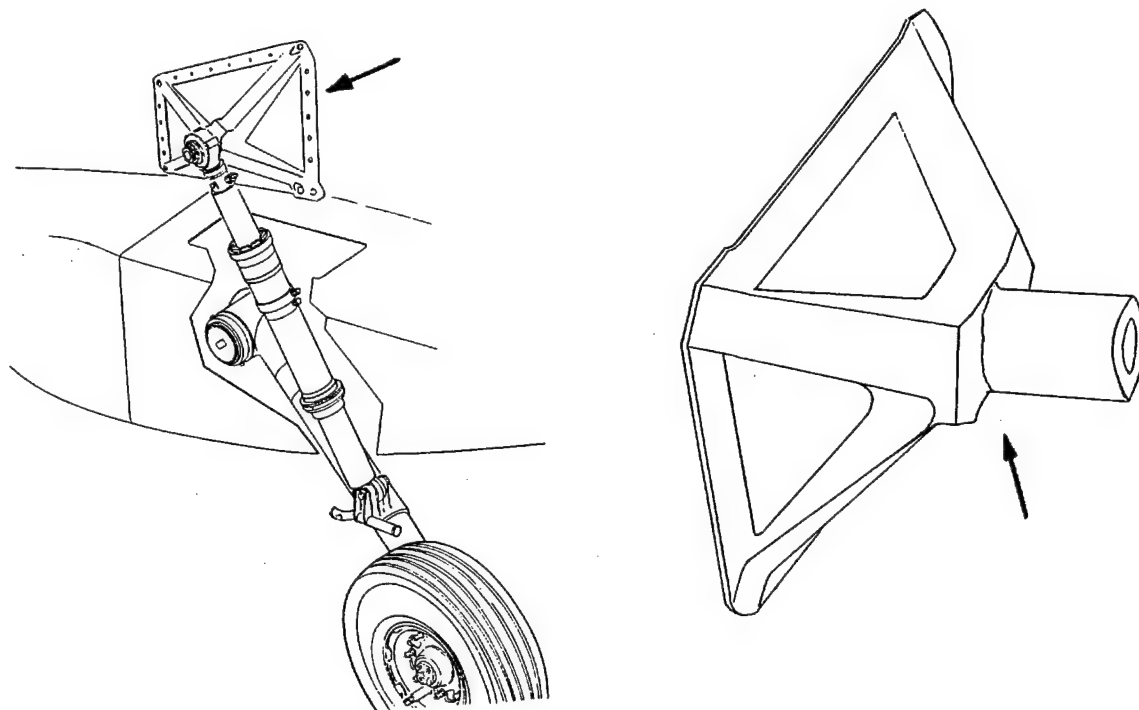
Figure 1. Schematic of the strut mount attached to the helicopter and the location of failure.

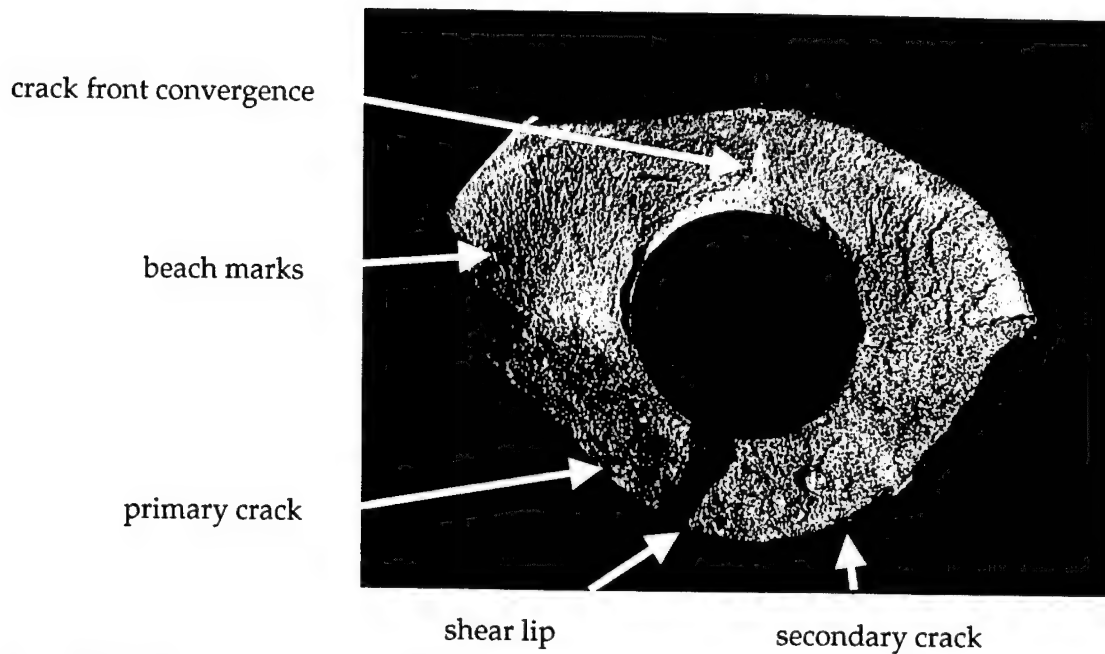
Figure 3. The fracture surface using oblique lighting. Note the shear lip separating the primary and secondary cracks, as well as the beach marks (mag. $\sim 1.4\times$).

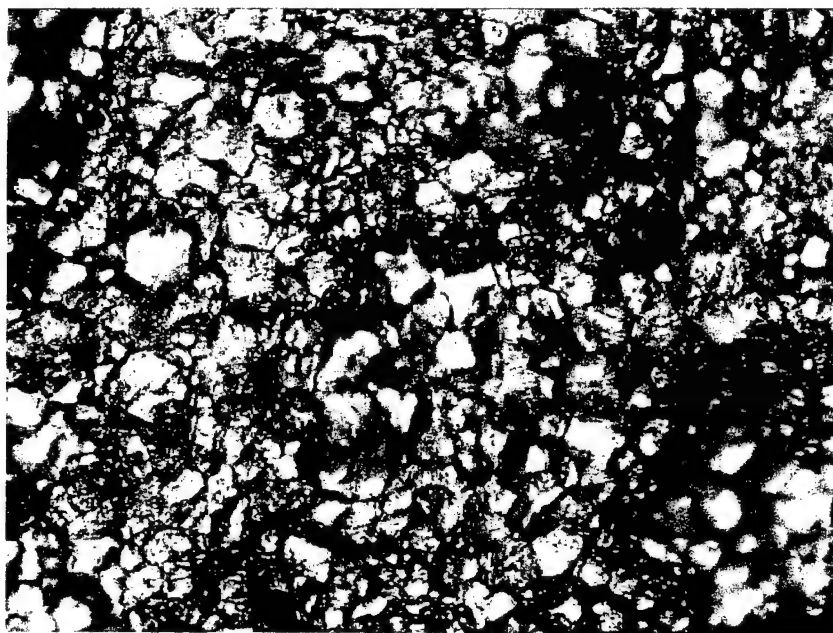
Figure 5. Intergranular morphology observed within secondary crack using light optical microscopy (mag. 30 \times).

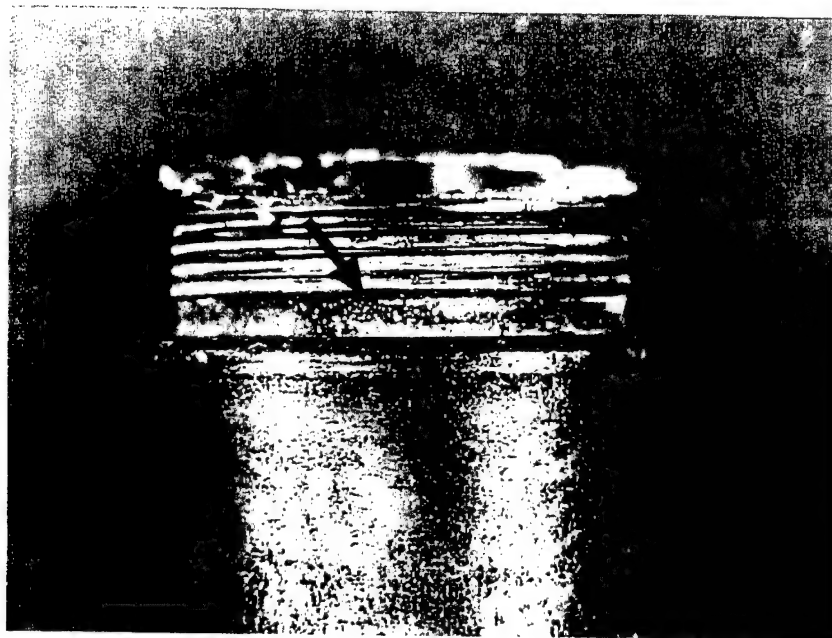
Figure 7. The only evidence of cadmium on the failed part was in the threads, shown here as a white, powdery corrosion product energy dispersive spectroscopy (energy dispersive spectroscopy [EDS] confirmed the presence of cadmium) (mag. $\sim 1.5\times$).

- Cadmium Plating: Numerous shock strut mounts have failed in the same location. A common link to each failure is the fact that the cadmium coating along the spindle and radius is worn off and corroded away, leading to corrosive attack. The use of a dry film lubricant could reduce wear in these regions.

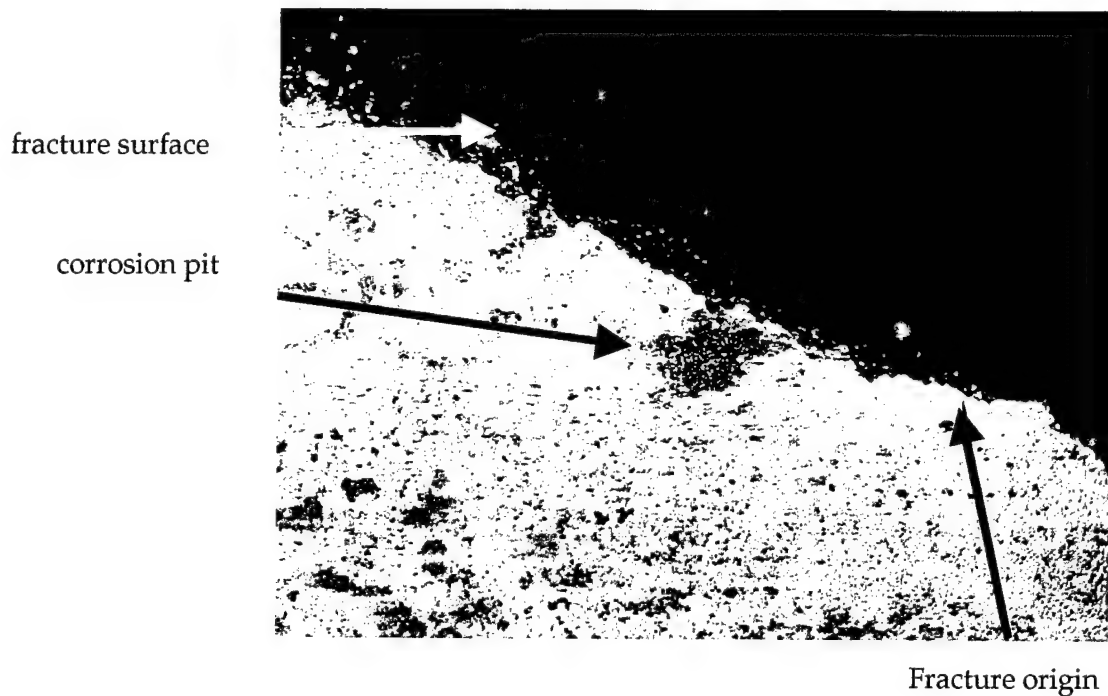
Figure 8. Corrosion pits adjacent to the primary origin (mag. 10 \times).

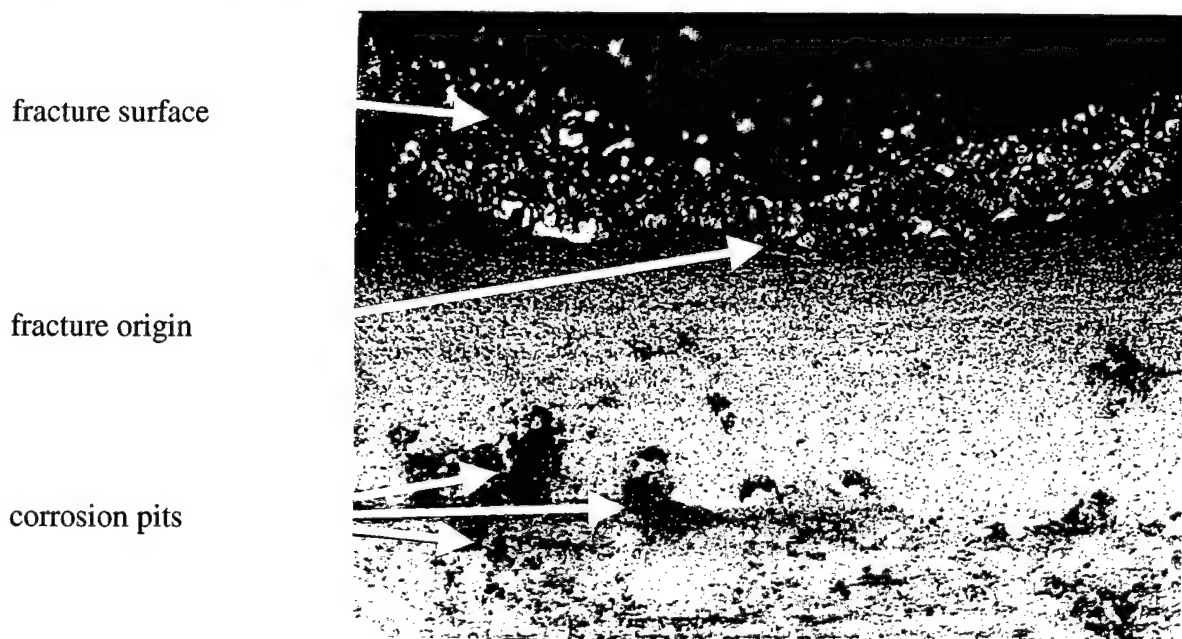
Figure 9. Corrosion pits adjacent to the secondary origin (mag. 10 \times).

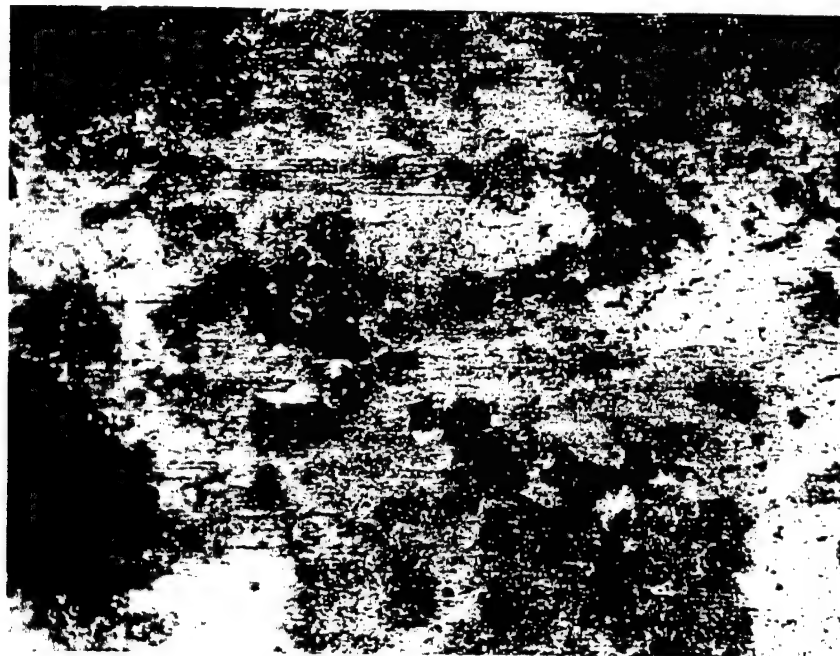
Figure 10. Group of pits observed along the spindle of the failed part. Pitting was prevalent along the spindle region (mag. 25 \times).

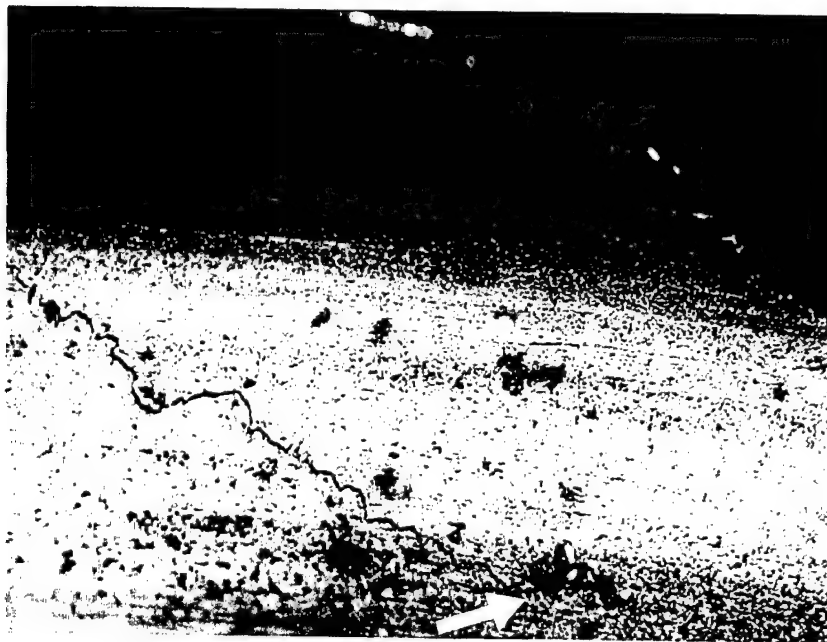
region. Also observed was a competing crack that was adjacent to the primary origin. Figure 11 shows the intergranular nature of this crack. There was also evidence of intergranular attack along this crack path. It was difficult to discern the exact location of the fracture origins; however, based upon the heavy corrosion in certain areas on both the primary and secondary crack surfaces, the general location of the origins was surmised.

Figure 11. Competing crack path adjacent to primary fracture surface. Note the intergranular nature of the crack, as well as the region of intergranular attack (mag. 15 \times).

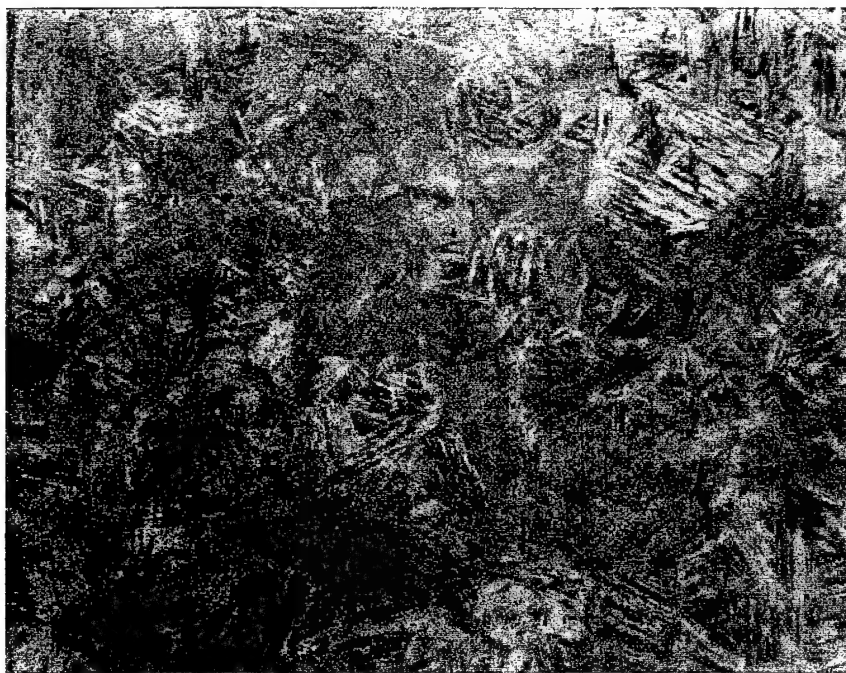
Figure 12. Microstructure of the material showing aged, low-carbon martensite in the longitudinal direction. Marble's Reagent (mag. 50×).

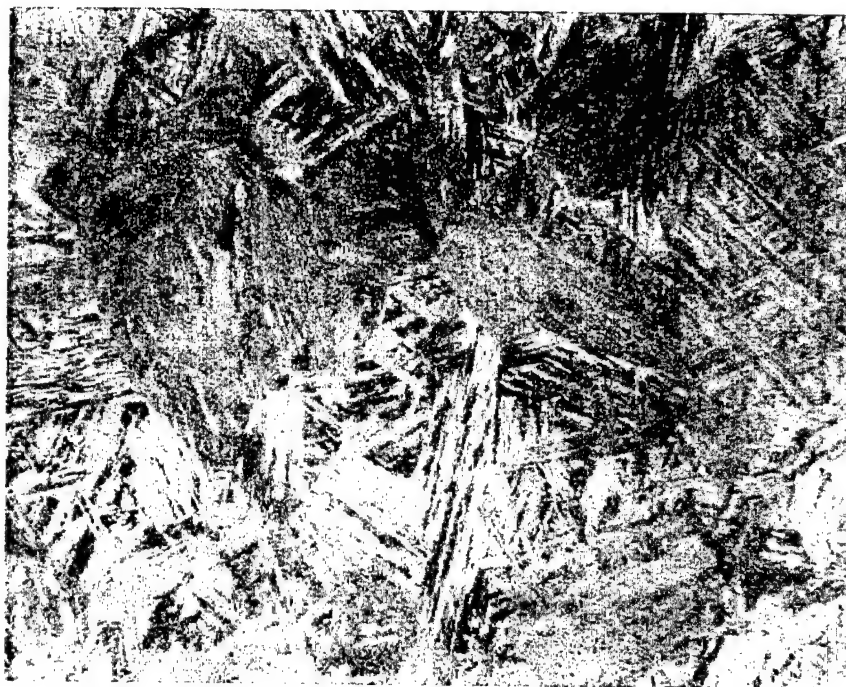
Figure 13. Microstructure similar to that in Figure 12 shown at higher magnification and in the transverse direction. Marble's Reagent (mag. 100 \times).

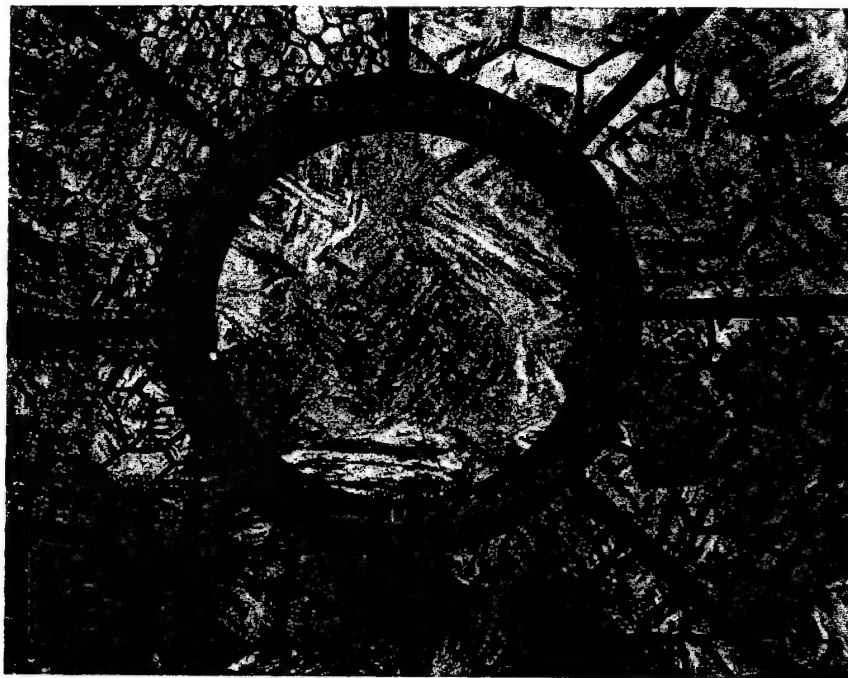
between nos. 2 and 3 at 100 \times magnification using the ASTM E112 charts over Figure 12. To verify this, a photomicrograph was taken using a grain size reticle, as shown in Figure 14. Again, the size was between nos. 2 and 3. The ASTM E112 charts indicate that the nominal diameter of the average grain is between 0.005 and 0.007 in, respectively for a grain size of nos. 3 and 2. A photomicrograph was subsequently taken of this structure at 100 \times , using an incremented reticle (Figure 15). As shown, the grain appear to have diameters ranging from 0.005–0.01 in, which correlated to the previous measurements. Subsequently, the intergranular fracture surface shown in Figure 18 (also see section 2.8) was also examined for grain size using the ASTM E112 "Fracture Grain Size" method. This technique is typically used for high-hardness, brittle steels with a predominantly martensitic structure, such as tool steels, high-carbon steels and martensitic stainless steels, and should be done with the specimen in the as-quenched or lightly tempered condition. Even though the Maraging 300 steel is a low-carbon alloy, the results obtained compared favorably to those from the other three methods. From Figure 18, the grain size ranged from ~100–200 μm , which correlated to a range of 0.004–0.008 in.

Figure 14. Microstructure of the material with grain size reticle overlay. The grain measured between nos. 2 and 3. Marble's Reagent (mag. 100×).

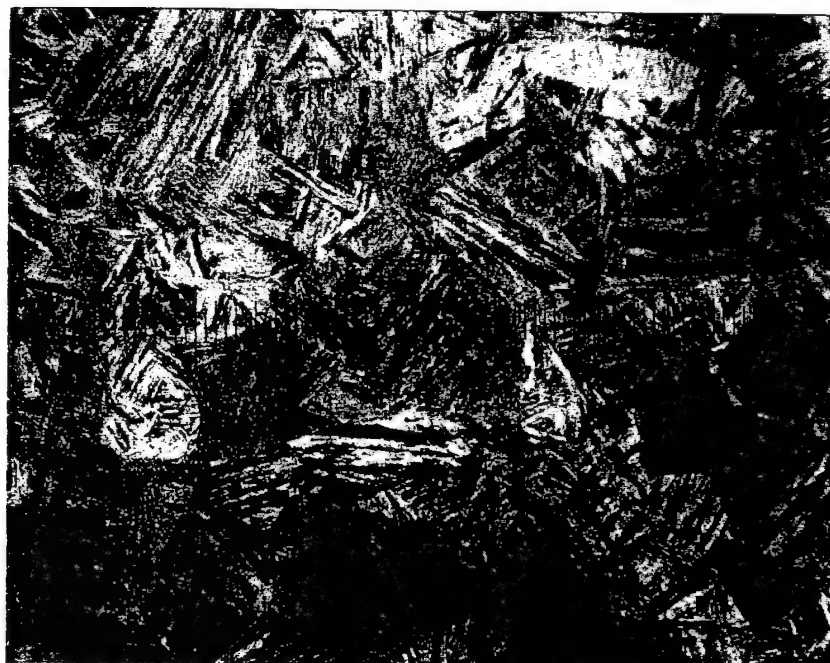
Figure 15. Microstructure of the material with incremented reticle overlay. The grain size measured between 0.005 and 0.01 in. Marble's Reagent (mag. 100×).

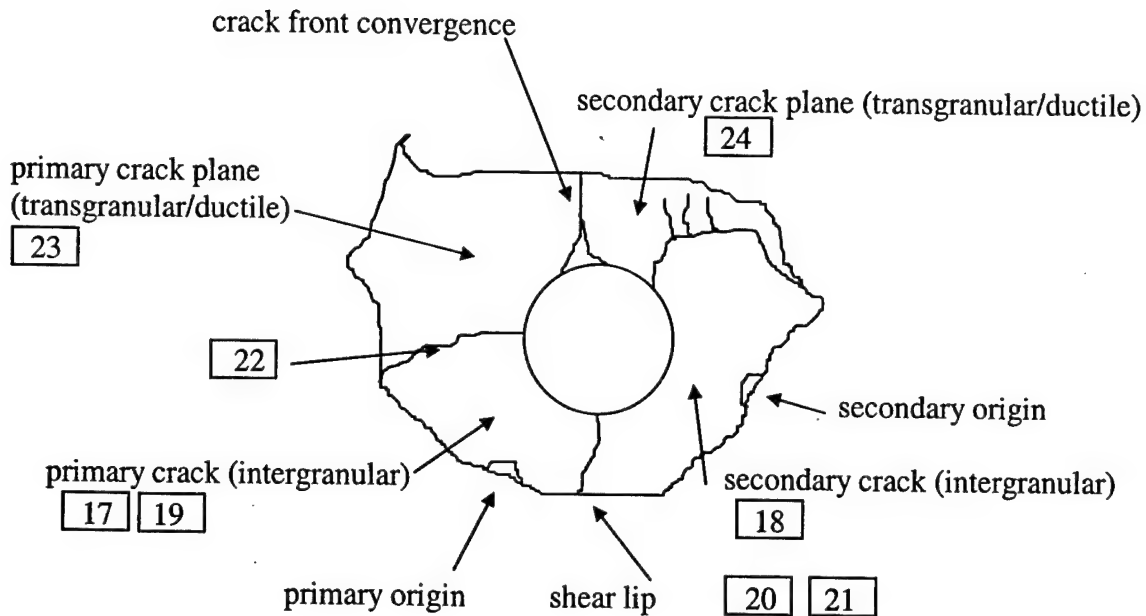
Figure 16. Schematic of fracture features as determined through SEM. Numbers in boxes correspond to figure locations.

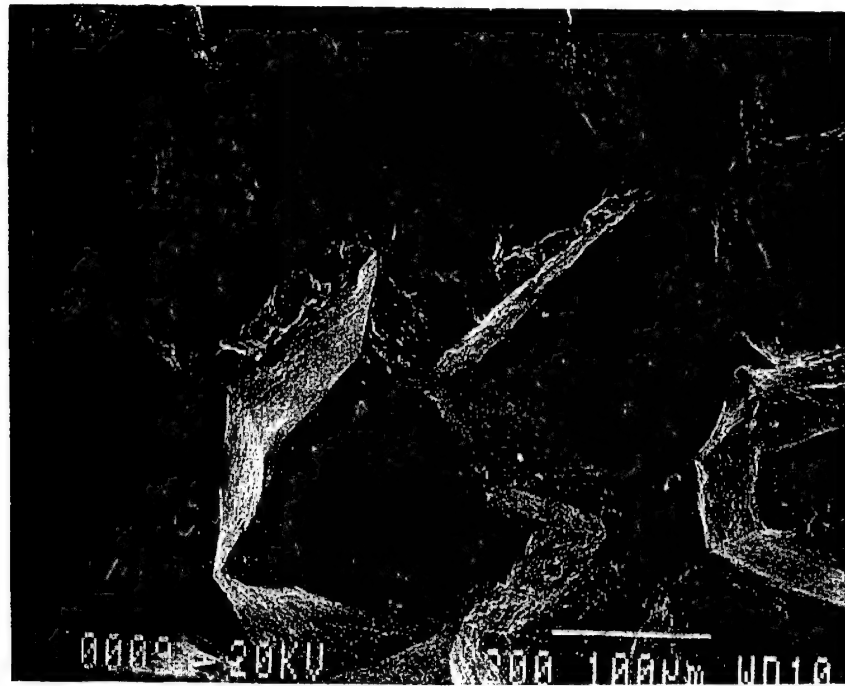
Figure 19. Magnified view of the intergranular morphology showing secondary cracking (mag. 200×).

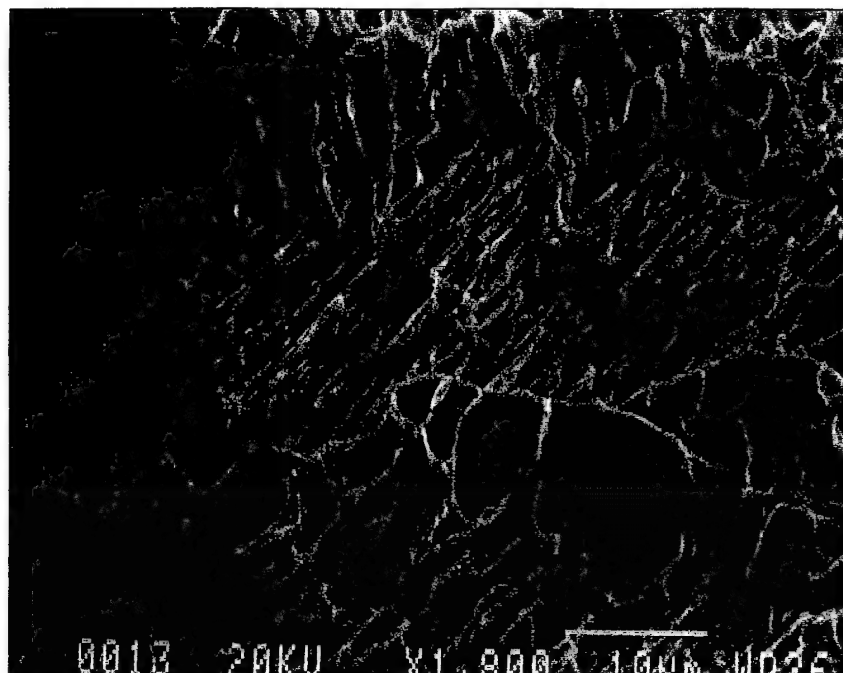
Figure 25. Transgranular/ductile morphology at higher magnification (mag. 1800×).

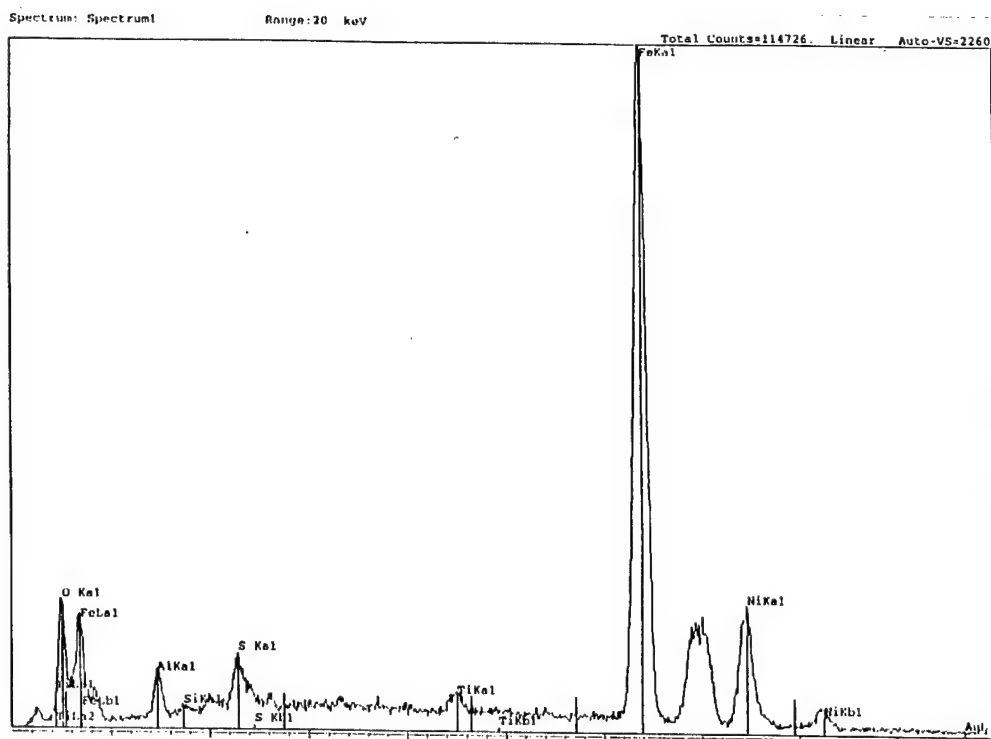
Figure 26. Representative EDS spectra of the spindle of the failed part. No evidence of cadmium was noted along the spindle.

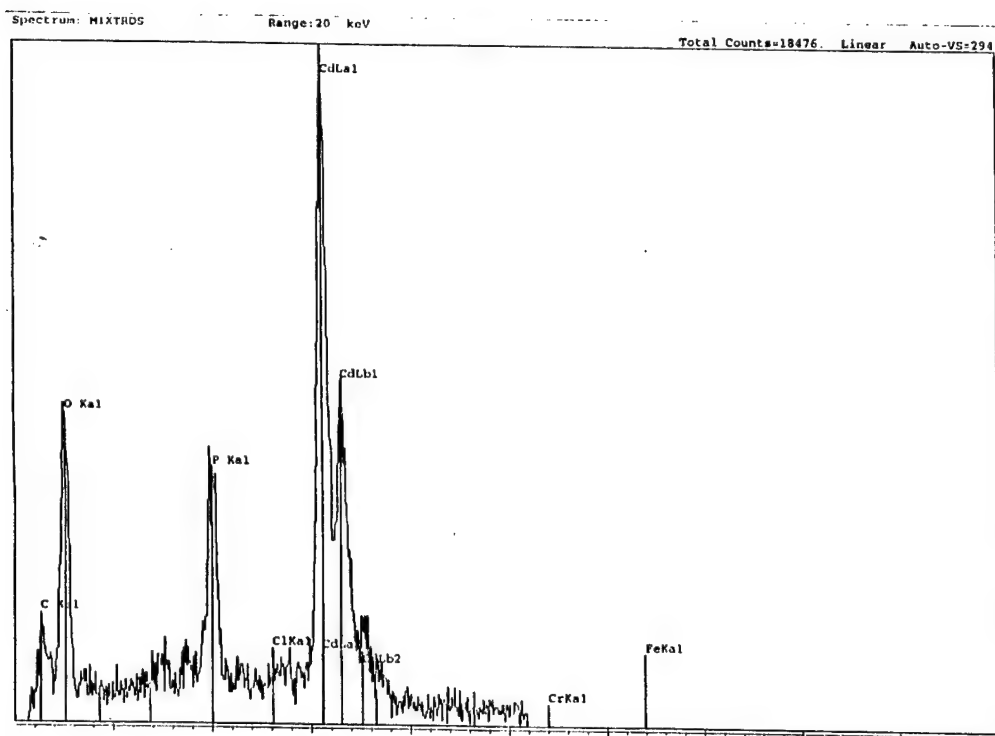
Figure 27. Representative EDS spectra within the threads of the failed part. Cadmium was noted within the threads.

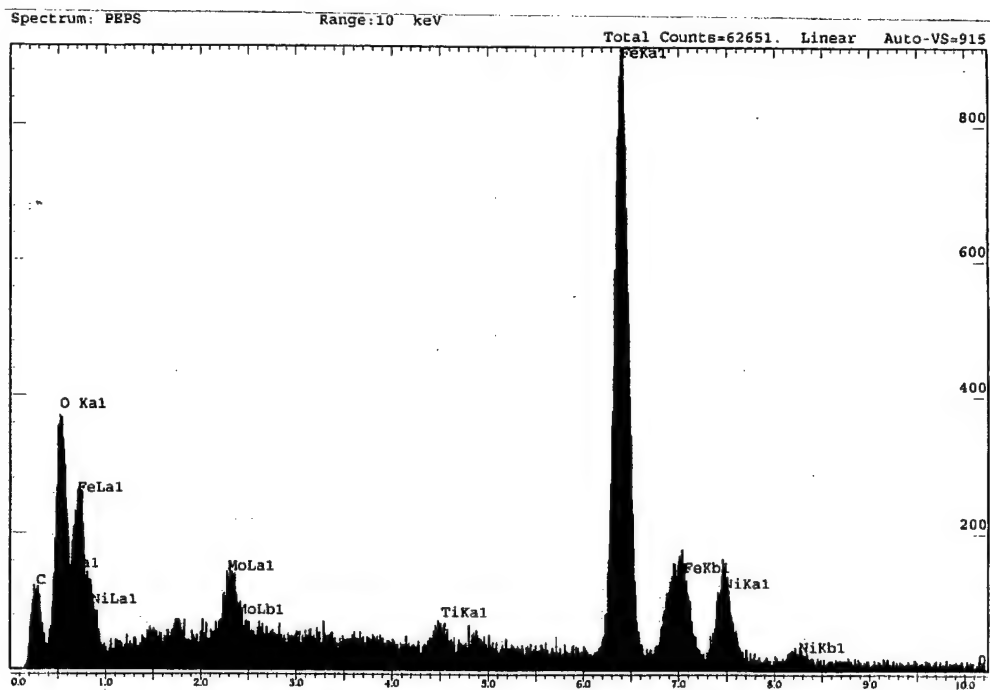
Figure 29. EDS spectra showing evidence of titanium within the precipitate shown in Figure 28. Other elements constitute the alloy.

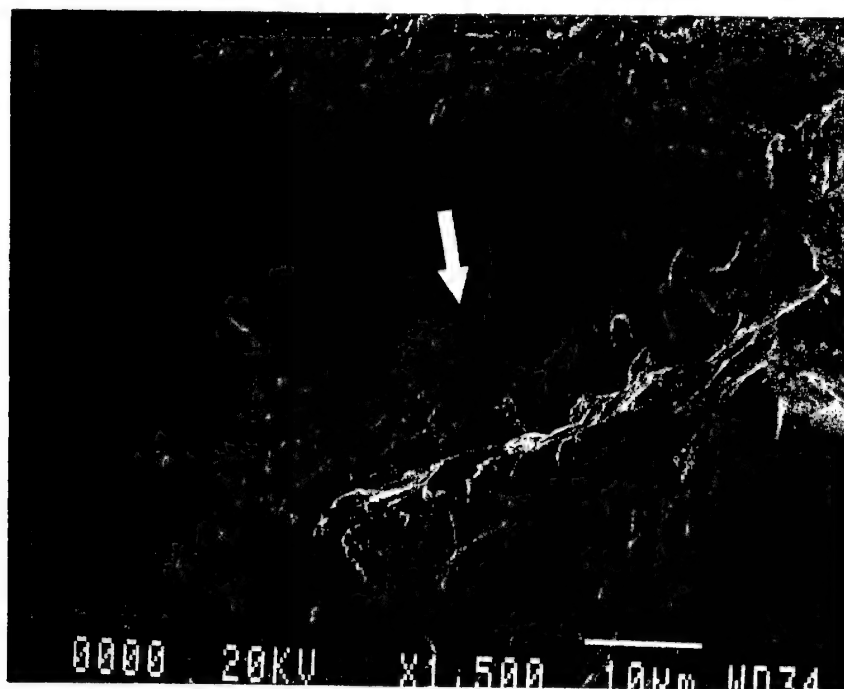
Figure 30. SEM micrograph of intergranular morphology of the primary fracture, showing the titanium-carbonitride precipitate that was examined using EDS (Figure 31) (mag. 1500 \times).

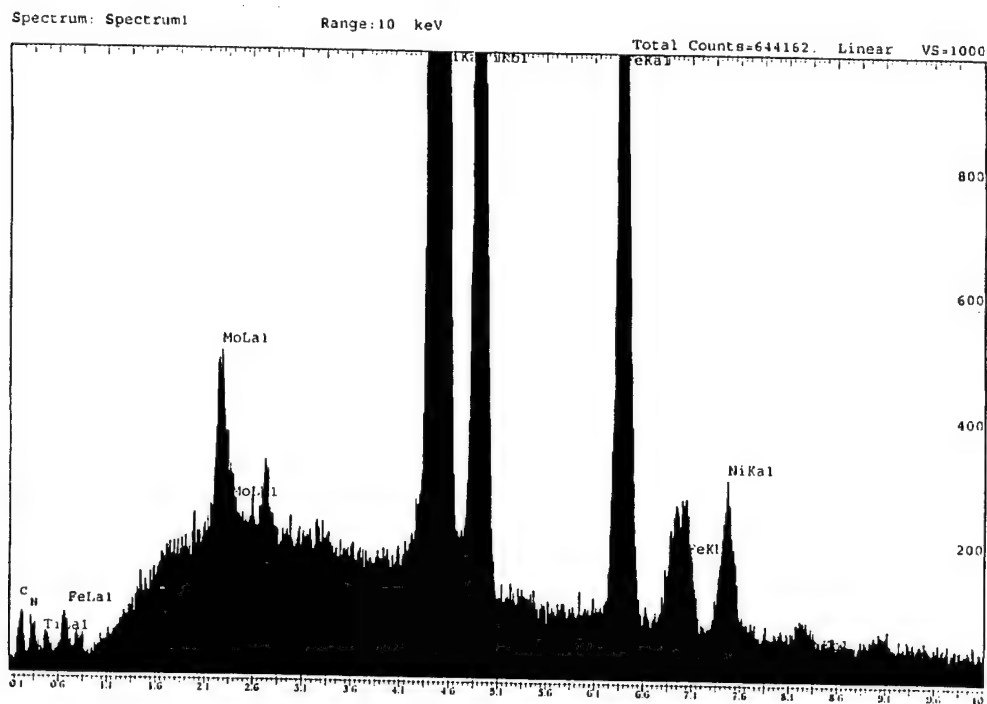
Figure 31. EDS spectra of the Ti (C, N) precipitate shown in Figure 30. Note the presence of titanium, carbon, and nitrogen, as well as the alloying elements.

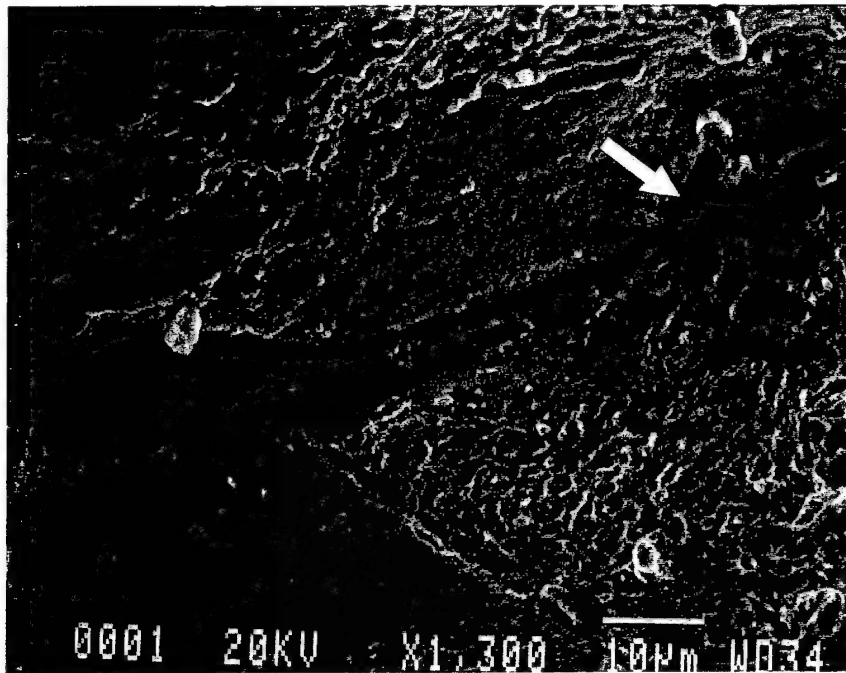
Figure 32. SEM micrograph of intergranular morphology of the primary fracture, showing another titanium-carbonitride precipitate (mag. 1300 \times).

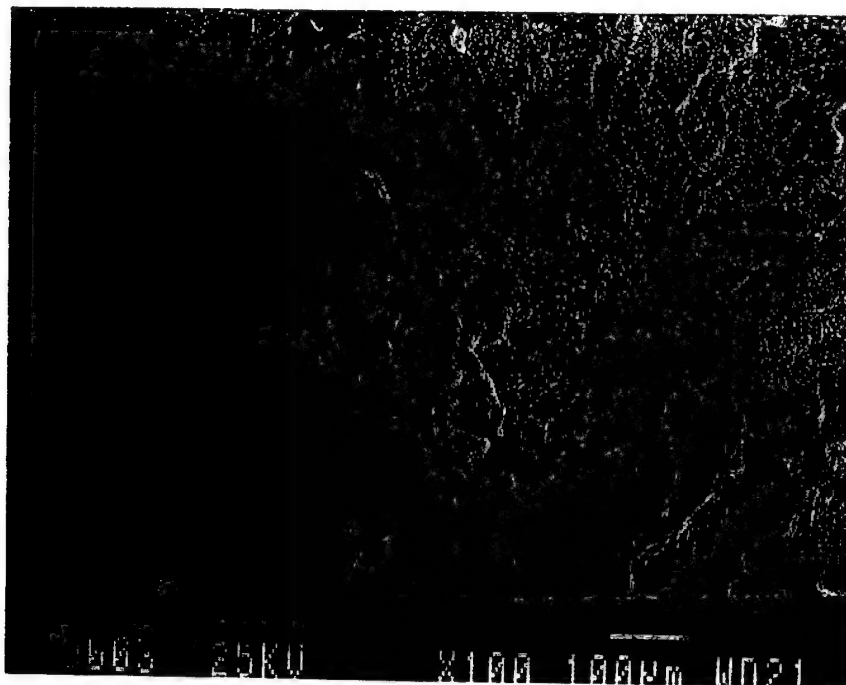
Figure C-12. Intergranular attack noted at origin no. 1 of Ft. Lewis specimen no. 3 (mag. 100 \times).

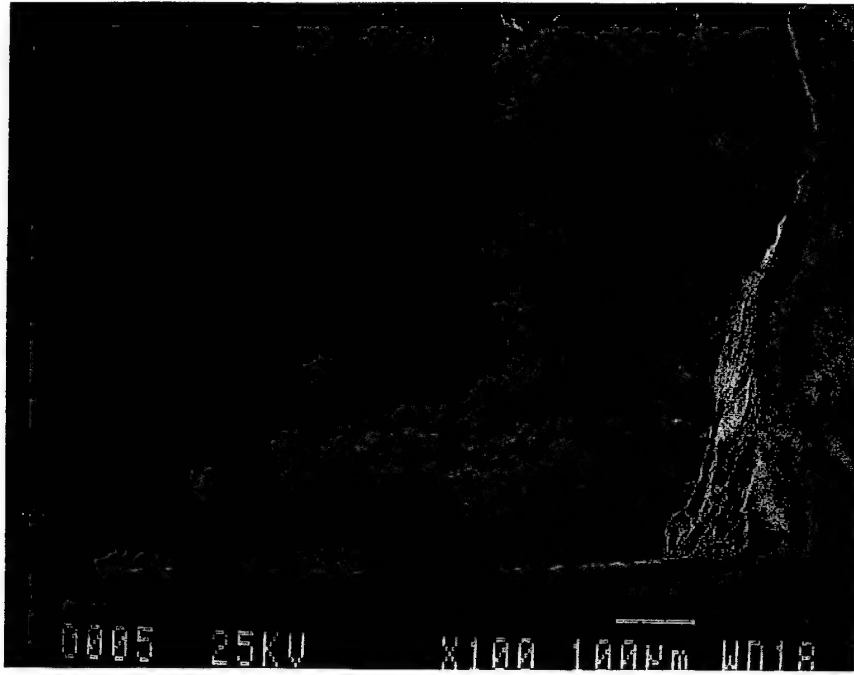
Figure C-14. Intergranular attack noted at origin no. 3 of Ft. Lewis specimen no. 3 (mag. 200 \times).

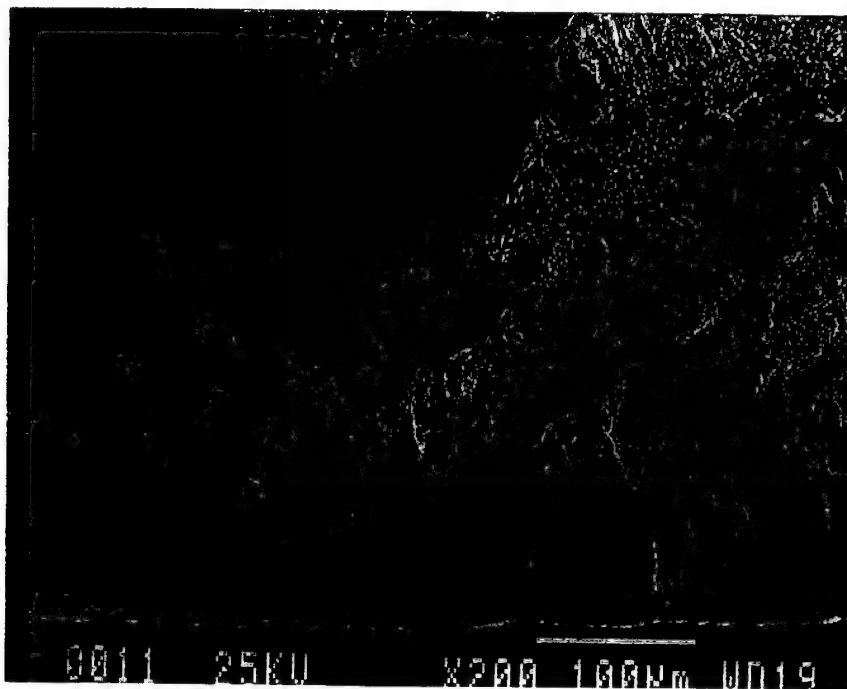
Figure C-16. Higher magnification of the intergranular attack noted at origin no. 2 (Figure C-13) of Ft. Lewis specimen no. 3 (mag. 200 \times).

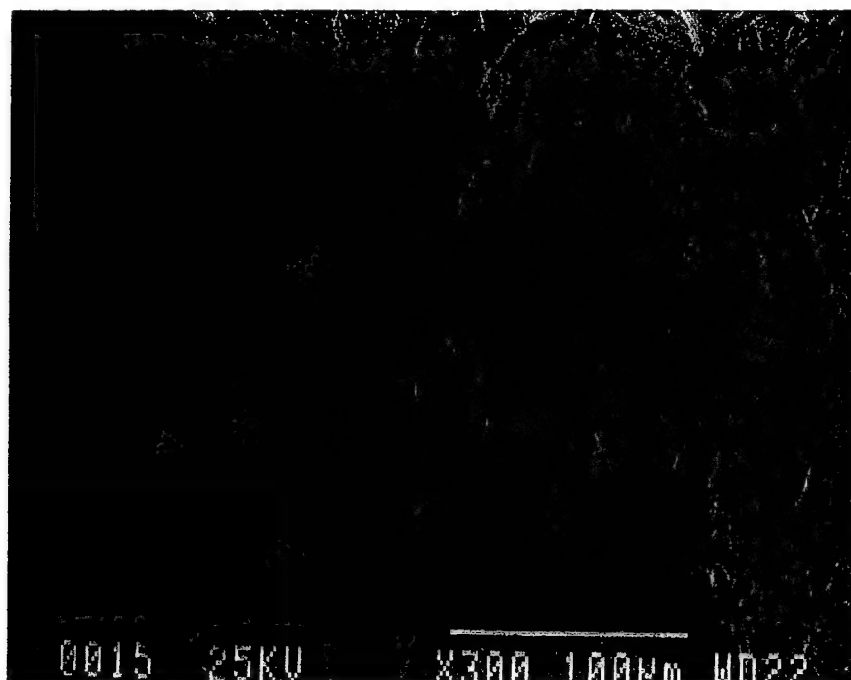
Figure C-18. Mixed mode morphology (intergranular and transgranular) noted close to origins within zone A Ft. Lewis specimen no. 3 (see Figure C-10) (mag. 300 \times).

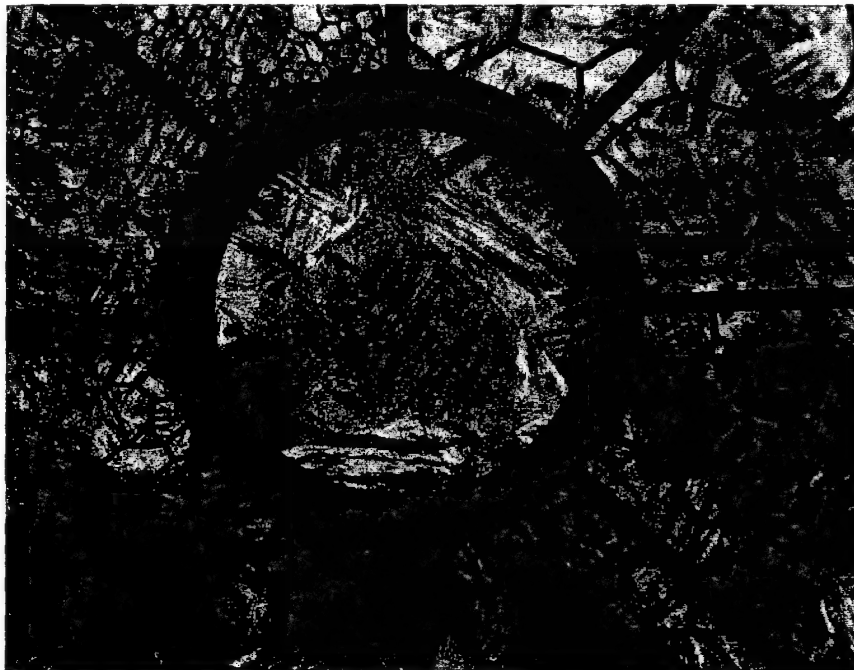
The grain size of failed Shock Strut Mount P/N 7-311113409, determined to be approximately double the required size (refer to section 2), was compared to the grain size of two scrap strut mounts. These strut mounts included one which had been sectioned into specimens that were cadmium brush plated at HAAF, Savannah, GA, and one that was sectioned for brush plating at Ft. Lewis, WA. The governing material specification, HMS 6-1081, *18% Nickel Maraging Steel - Bars and Forgings, 300,000 psi (2069 Mpa) Yield Strength Grade*, requires a grain size of no. 7 or finer with an occasional no. 5. It was determined that the grain size of the failed strut mount was between American Society for Testing and Materials (ASTM) nos. 2 and 3. Figure D-1 shows the grain size of the failed part, with a grain size reticle overlay at 100 \times magnification. Figure D-2 shows a scanning electron micrograph of the actual grain size observed within the intergranular fracture surface at 200 \times magnification.

Figure D-1. Grain size of the failed strut mount with reticle overlay (mag. 100 \times).

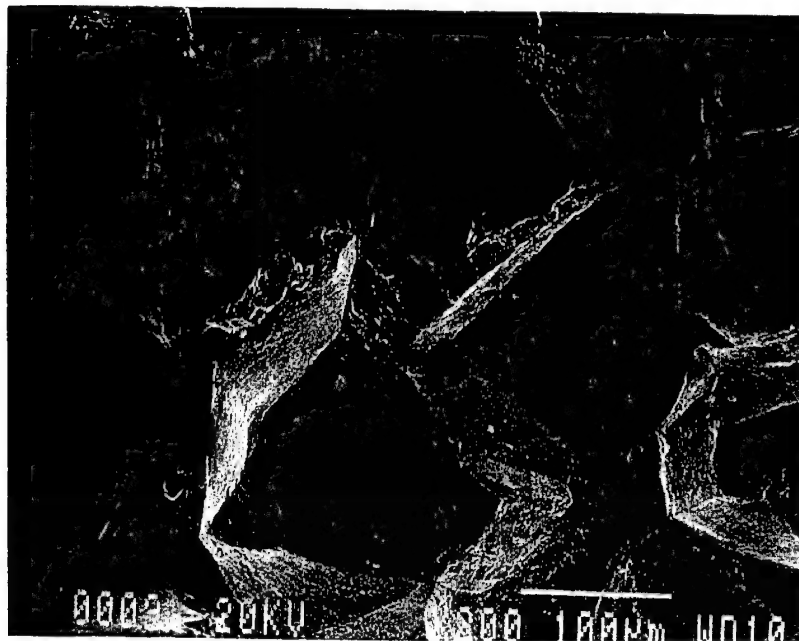
Figure D-2. Grains from the intergranular fracture surface of the failed strut mount (mag. 200 \times).
